Re: 1966 NW Lutes Rd., Poulsbo

**Inspection Report**  
**1966 NW Lutes Rd.**  
**Hayden, ID 83835**  
**Prepared for: Mr. John Doe**

**Prepared by:**  
**Dan Maloney**  
**Lighthouse Home Inspection, LLC**  
**PO Box 3266**  
**Hayden, 83835**  
**208-660-1223**

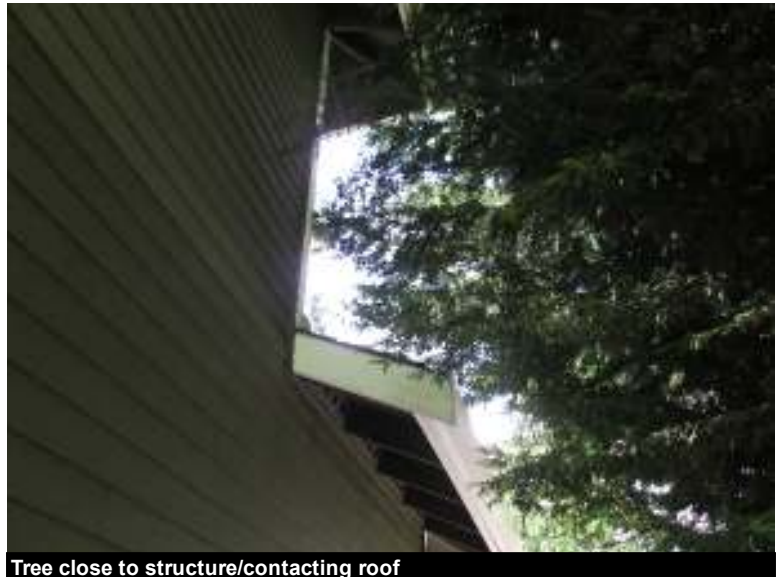
**CONDITION:** Grounds appear to be maintained. Trees planted close to structure near detached garage. Removal or trimming is recommended to prevent contact with the siding or roof.

Tree close to structure/contacting roof

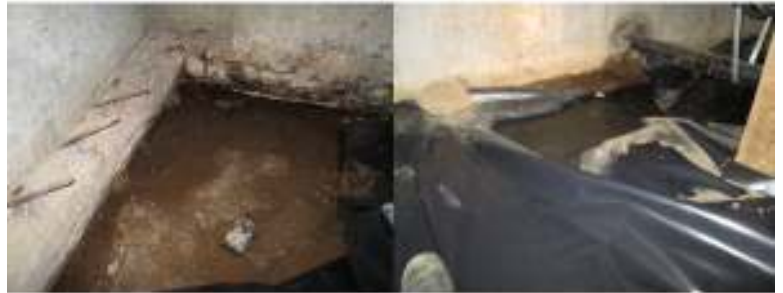
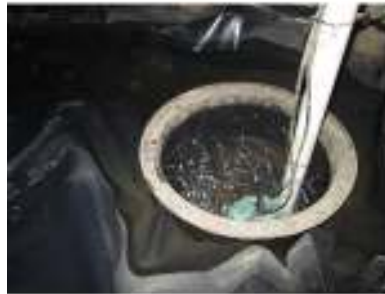
A sump pump was found at the following location: Crawlspace; The sump pump was functional only when the float was manually lifted. A significant amount of water was found to be collecting around the sump and the surrounding crawlspace area. Repairs/adjustment is needed to the float to allow the switch to engage when water enters the sump area.

Sump pump and standing water

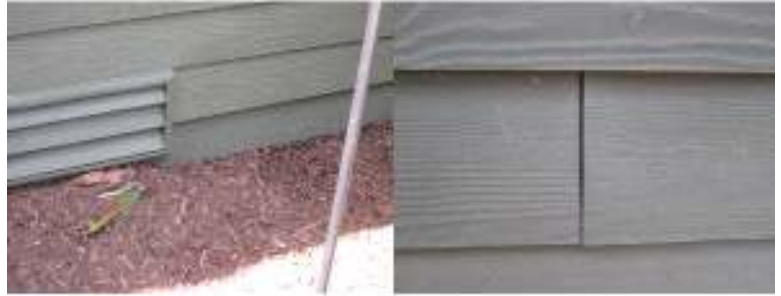
Siding appears functional without damage. Exterior paint appears serviceable. Exterior caulking was found to be deteriorated at one or more areas around the exterior.

Siding low/Open gaps at siding butt joints

Recommend re-caulking siding butt joints, corner boards, and around any trim

boards that are attached to the exterior walls. Caulking is not a permanent fix and will need to be re-applied every couple of years to seal the exterior walls. Recommend further evaluation and repairs by a siding specialist due to the observations noted.

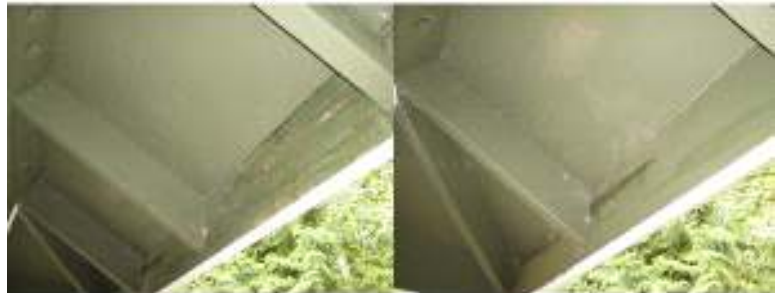
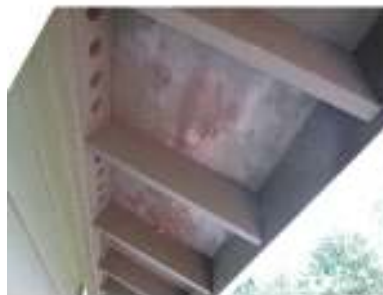
Fascia boards were found to be damaged/rotted from moisture at the South/East corner of home.

Typically, water will run off the roof edge into the gutter runs.

Rotted/wet fascia boards

Recommend replacing any damaged fascia boards and installing flashing at upper edge to prevent future rot damage. Consult with a licensed siding contractor as needed for repairs. Also, upper soffits at rear of home were found with mildew. Recommend cleaning and re-painting as needed.

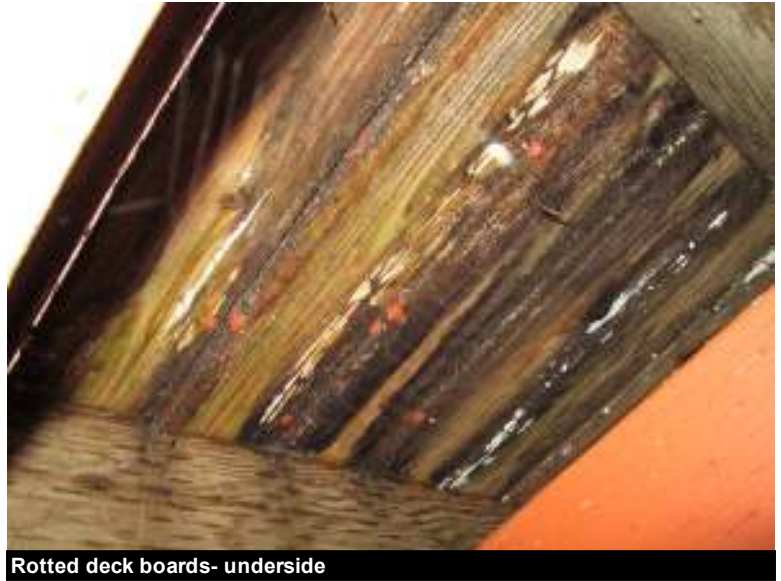
**CONDITION:** The decking boards appeared mostly functional and without extensive rot conditions. Some wood rot was evident under decking boards outside of the downstairs office. Replace as needed. Flashing was found to be installed above the header joist where the deck is attached to the home. Lag bolts were not installed securing the deck structure to the exterior wall of the home. It is recommended that bolts be installed to prevent the deck structure from separating from the exterior wall.

**Rotted deck boards- underside**

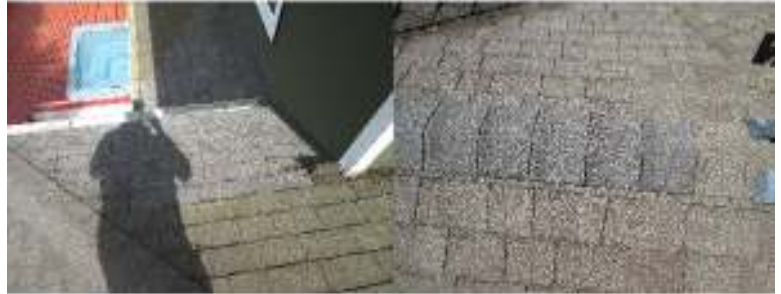
**CONDITION:** The roofing material appears functional and within useful life. Evidence of recent roof repairs were noted at rear of home and at ridge vent caps. Consult with seller regarding history of repairs and obtain receipts/ invoices for all repair work.

Evidence of roof repairs

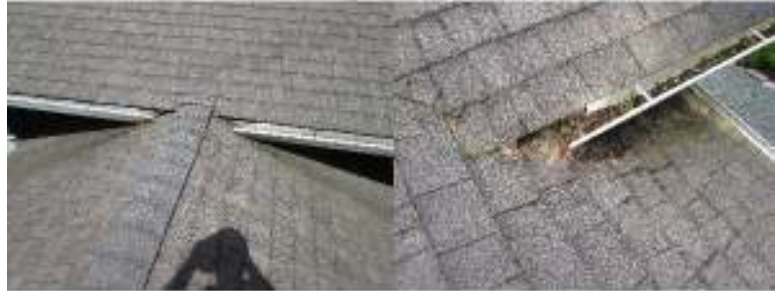
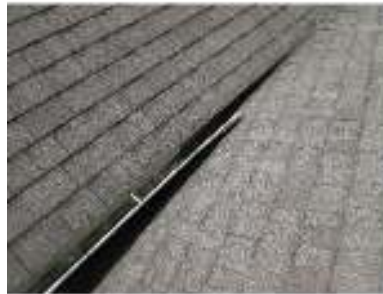
Gutter s blcoked by debris

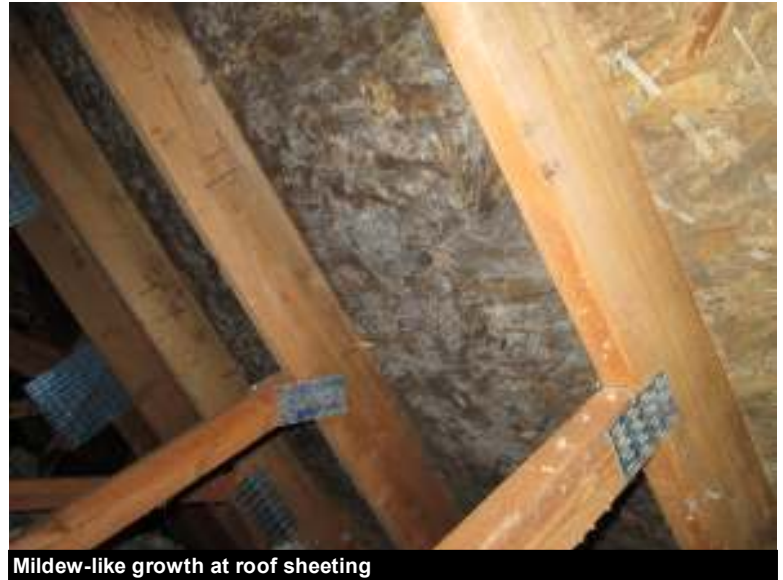
The attic space was accessible and traversed, All exhaust fan ductwork appears to be properly connected and venting to the exterior of the structure. Attic ventilation appears adequate. All vents appear to be clear and open. Mildew/ Mold-like growth was noted in the attic at roof sheeting/rafters/trusses at second story attic space. Generally, this is caused by lack of

Mildew-like growth at roof sheeting

proper ventilation throughout the attic space and improperly ducted household vents. It is recommended that corrective actions be taken to reduce the excessive moisture conditions in the attic space. Also, it is recommended that you consult a mold remediation specialist expert to resolve the existing conditions. Unable to determine the exact source of excessive moisture. Ventilation appeared adequate with clear soffit vents and a ridge vent. Consult with the seller regarding any previous history of disconnected exhaust fan ducting- this is a primary source for excessive moisture conditions in attic spaces. A licensed roofing contractor should be consulted to make further evaluation and repairs as needed.

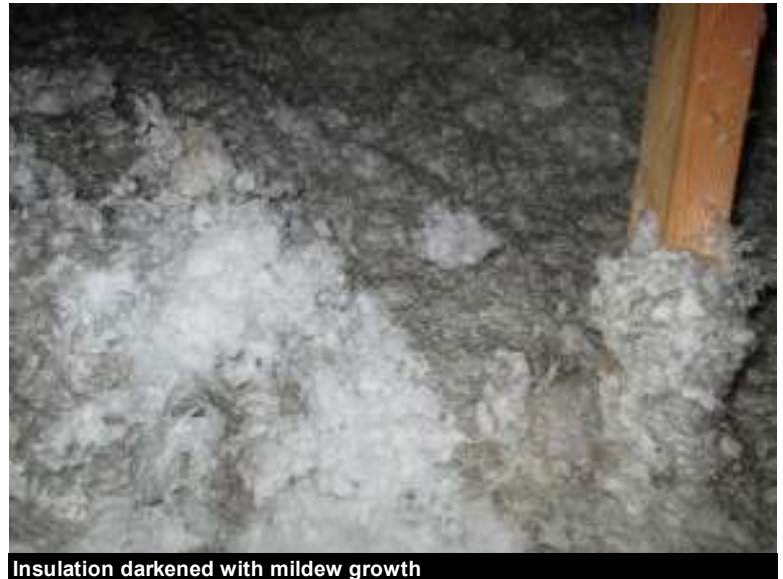
Fiberglass- Blown; Mildew-like growth was noted at surface of insulation. Typically this is caused by poor attic ventilation or bathroom exhaust ducts terminating in the attic.

Insulation darkened with mildew growth

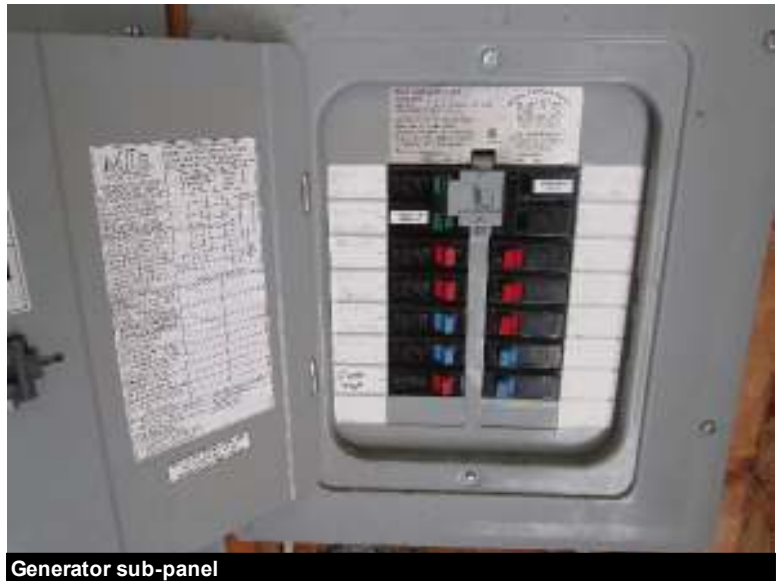
**SUB PANEL NOTES:** 30 AMP. A sub-panel designed for use with a generator was found. No test was performed with a generator. Consult with the seller regarding operating instructions and generator specifications. Electrical connections for a portable generator are beyond the scope of this inspection. Inspection of portable generator hook-up by a licensed electrician is

Generator sub-panel

recommended. Circuit and wire sizing correct so far as visible, Grounding system is present.

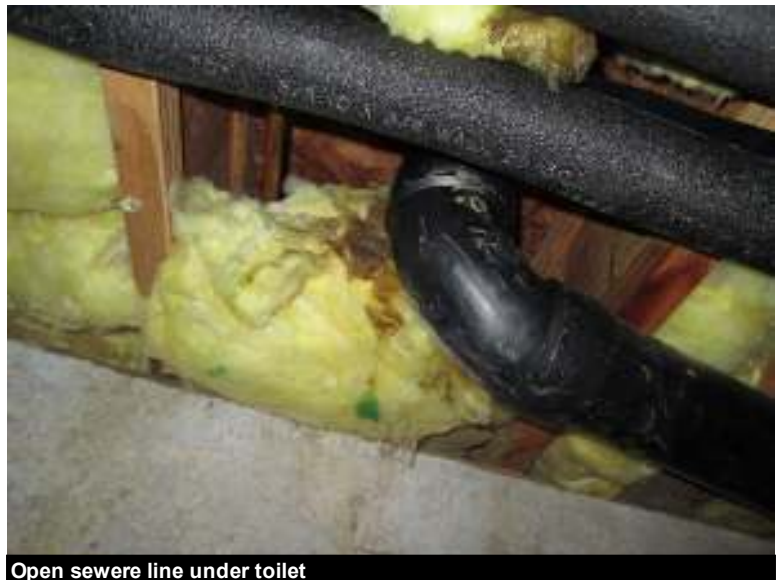
**CONDITION:** Active leakage was noted at toilet drain line under half bathroom toilet. Water was found to be leaking from floor flange area. Surrounding sub-flooring and insulation were wet with pooled water under toilet. Recommend contacting a licensed plumber to evaluate the need for repairs.

Open sewere line under toilet

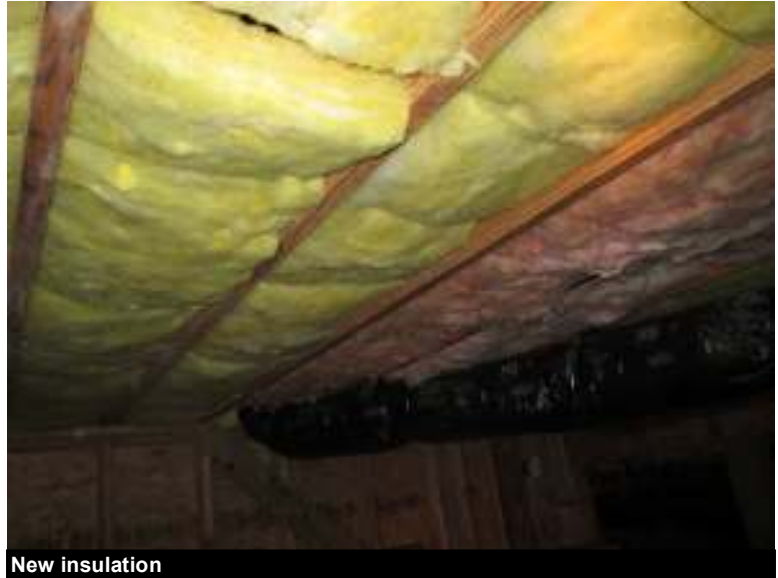
Sub-floor insulation present and secure between floor joists. It appears that some insulation was recently replaced- possibly secondary to rodent infestation. Recommend consulting with seller as needed. Crawlspace vents appeared adequate and provided ventilation of the sub-structural area. A vapor barrier was found to be installed throughout the

crawlspace with proper coverage of the earth floor. Some evidence of standing water was noted under the vapor barrier in various areas when crawled on. Any pooled water should be channeled to the sump pump area to be evacuated.

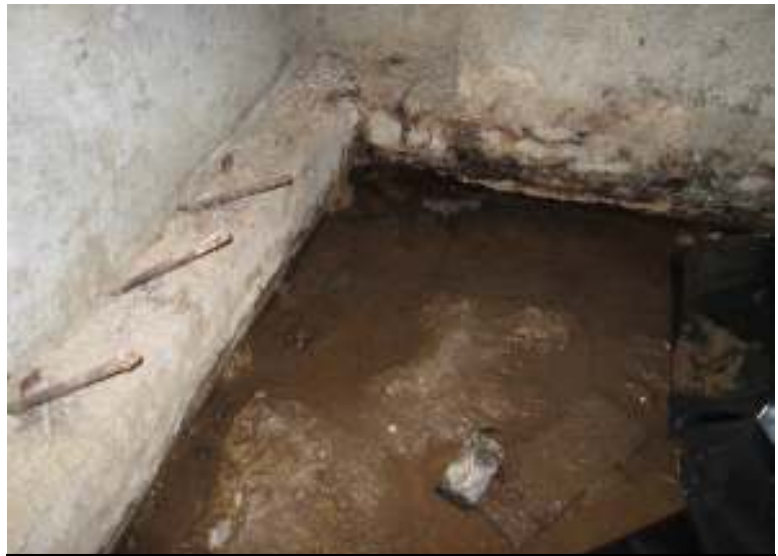
The following problems were noted at the sump: The sump pump would not engage due to the float being displaced by the standing water. Adjustment/repairs are recommended. Also, pockets of standing water were noted under vapor barrier in several areas. Recommend trenching the earth floor to make sure all water drains towards the sump pump.

Contact a drainage specialist for further evaluation and repairs as needed. Unable to locate the source of water entry.
